# CLIMATIC TEST REPORT

## SAND AND DUST TEST

**According to the standard(s):**  
RTCA DO160 G (2010) Section 12 Category S

**Equipment under test:**  
MU-NG & SU-NG

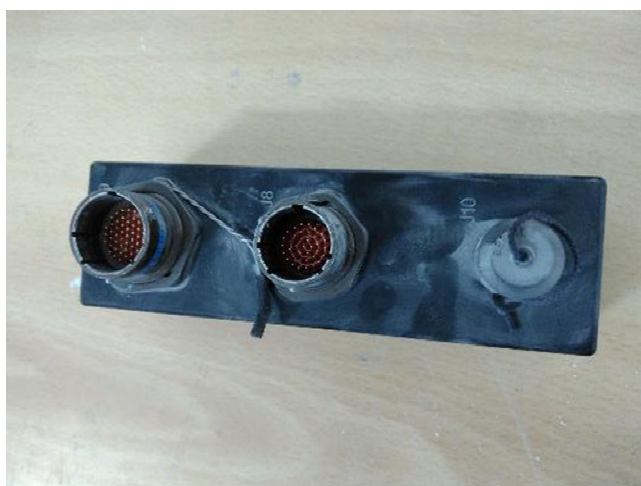
photo 154

At the end of the tests, no visual degradation was observed. There is sand inside a connector.
